Manhole Inspection Summary

Manhole # S25I__043MH

Insp Date: **3/17/08 9:54 AM**

Location Address: **W.PRATT ST.**

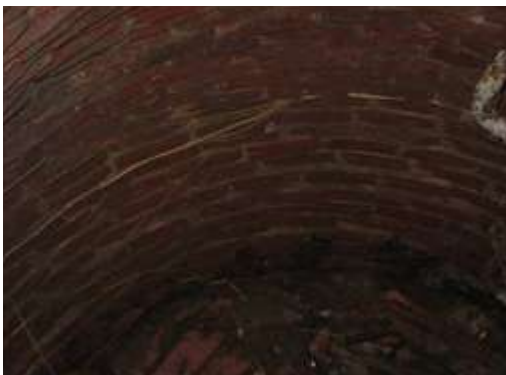
Defect 1

Condition: ☐ Sound ☐ Cracked ☒ **Root Intrusion** ☐ Loose Brick ☐ Deteriorated

ROOT INTRUSION AT THE CORBEL

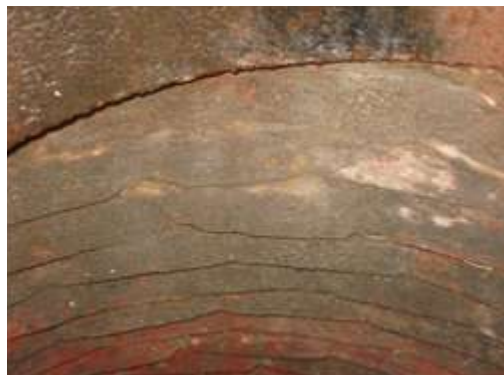
Defect 6

Infiltration: ☐ None ☐ Joint ☐ Cracks ☐ Mortar ☐ Roots ☒ **Wall**

EVIDENCE OF INFILTRATION AT THE CORBEL

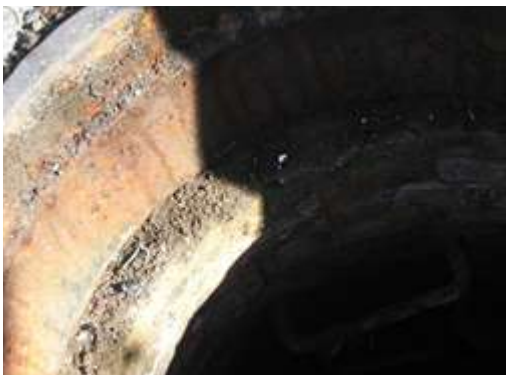
Defect 4

Frame Offset: **1.5** (in.) Condition: ☒ Sound ☐ Cracked ☐ Leaks

1.5 IN FRAME OFFSET

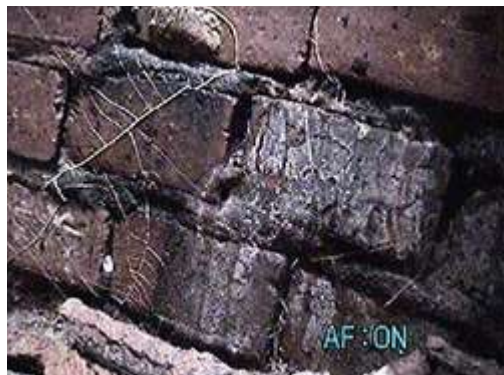
Defect 3

Condition: ☐ Sound ☐ Cracked ☒ **Root Intrusion** ☐ Loose Brick ☐ Deteriorated

Infiltration: ☐ None ☐ Joint ☐ Cracks ☒ **Mortar** ☒ **Roots** ☐ Wall

ROOT INTRUSION AND INFILTRATION AT THE BARREL

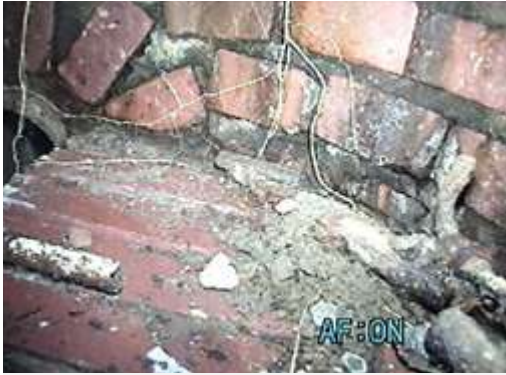
Defect 2

EVIDENCE OF BARREL INFILTRATION
WITH ROOT INTRUSION AND DEBRIS
ON BENCH

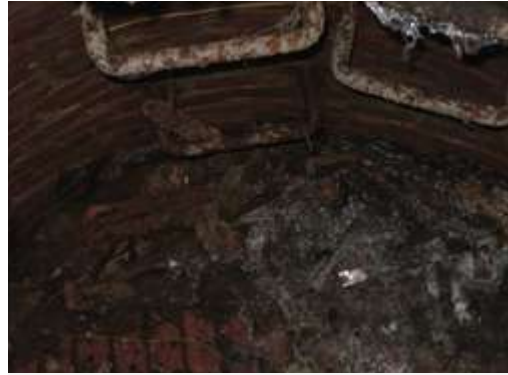
Defect 7

Steps Count: **5** Missing: **0** ☒ **Corroded**

CORRODED STEPS AND DEBRIS ON
BENCH

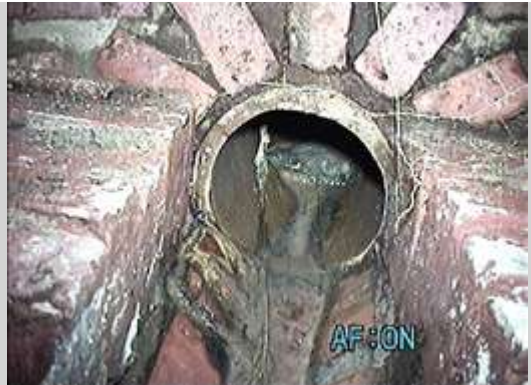
6 O'Clock Inflow

Deposits: ☐ None ☒ **Mud** ☐ Sludge ☐ Debris ☐ Grease

Silt Depth: **0.5** (in.) Deposits Extent: **Light**
